Coverage of Archaeological Ruins of the Abbey of St-Maurice

Savioz Fabrizzi Architectes

Project: Coverage of Archaeological Ruins of The Abbey of St-Maurice
 Location: Saint Maurice, Switzerland
 Architects: Savioz Fabrizzi Architectes
 Civil engineers: Alpatec sa / Client: Abbey of St-Maurice
 Program: Protection roof for the archaeological ruins
 Bldg. area: 1,400m² / Design: 2004 / Construction: 2009-2010
 Photograph: ©Thomas Jantscher

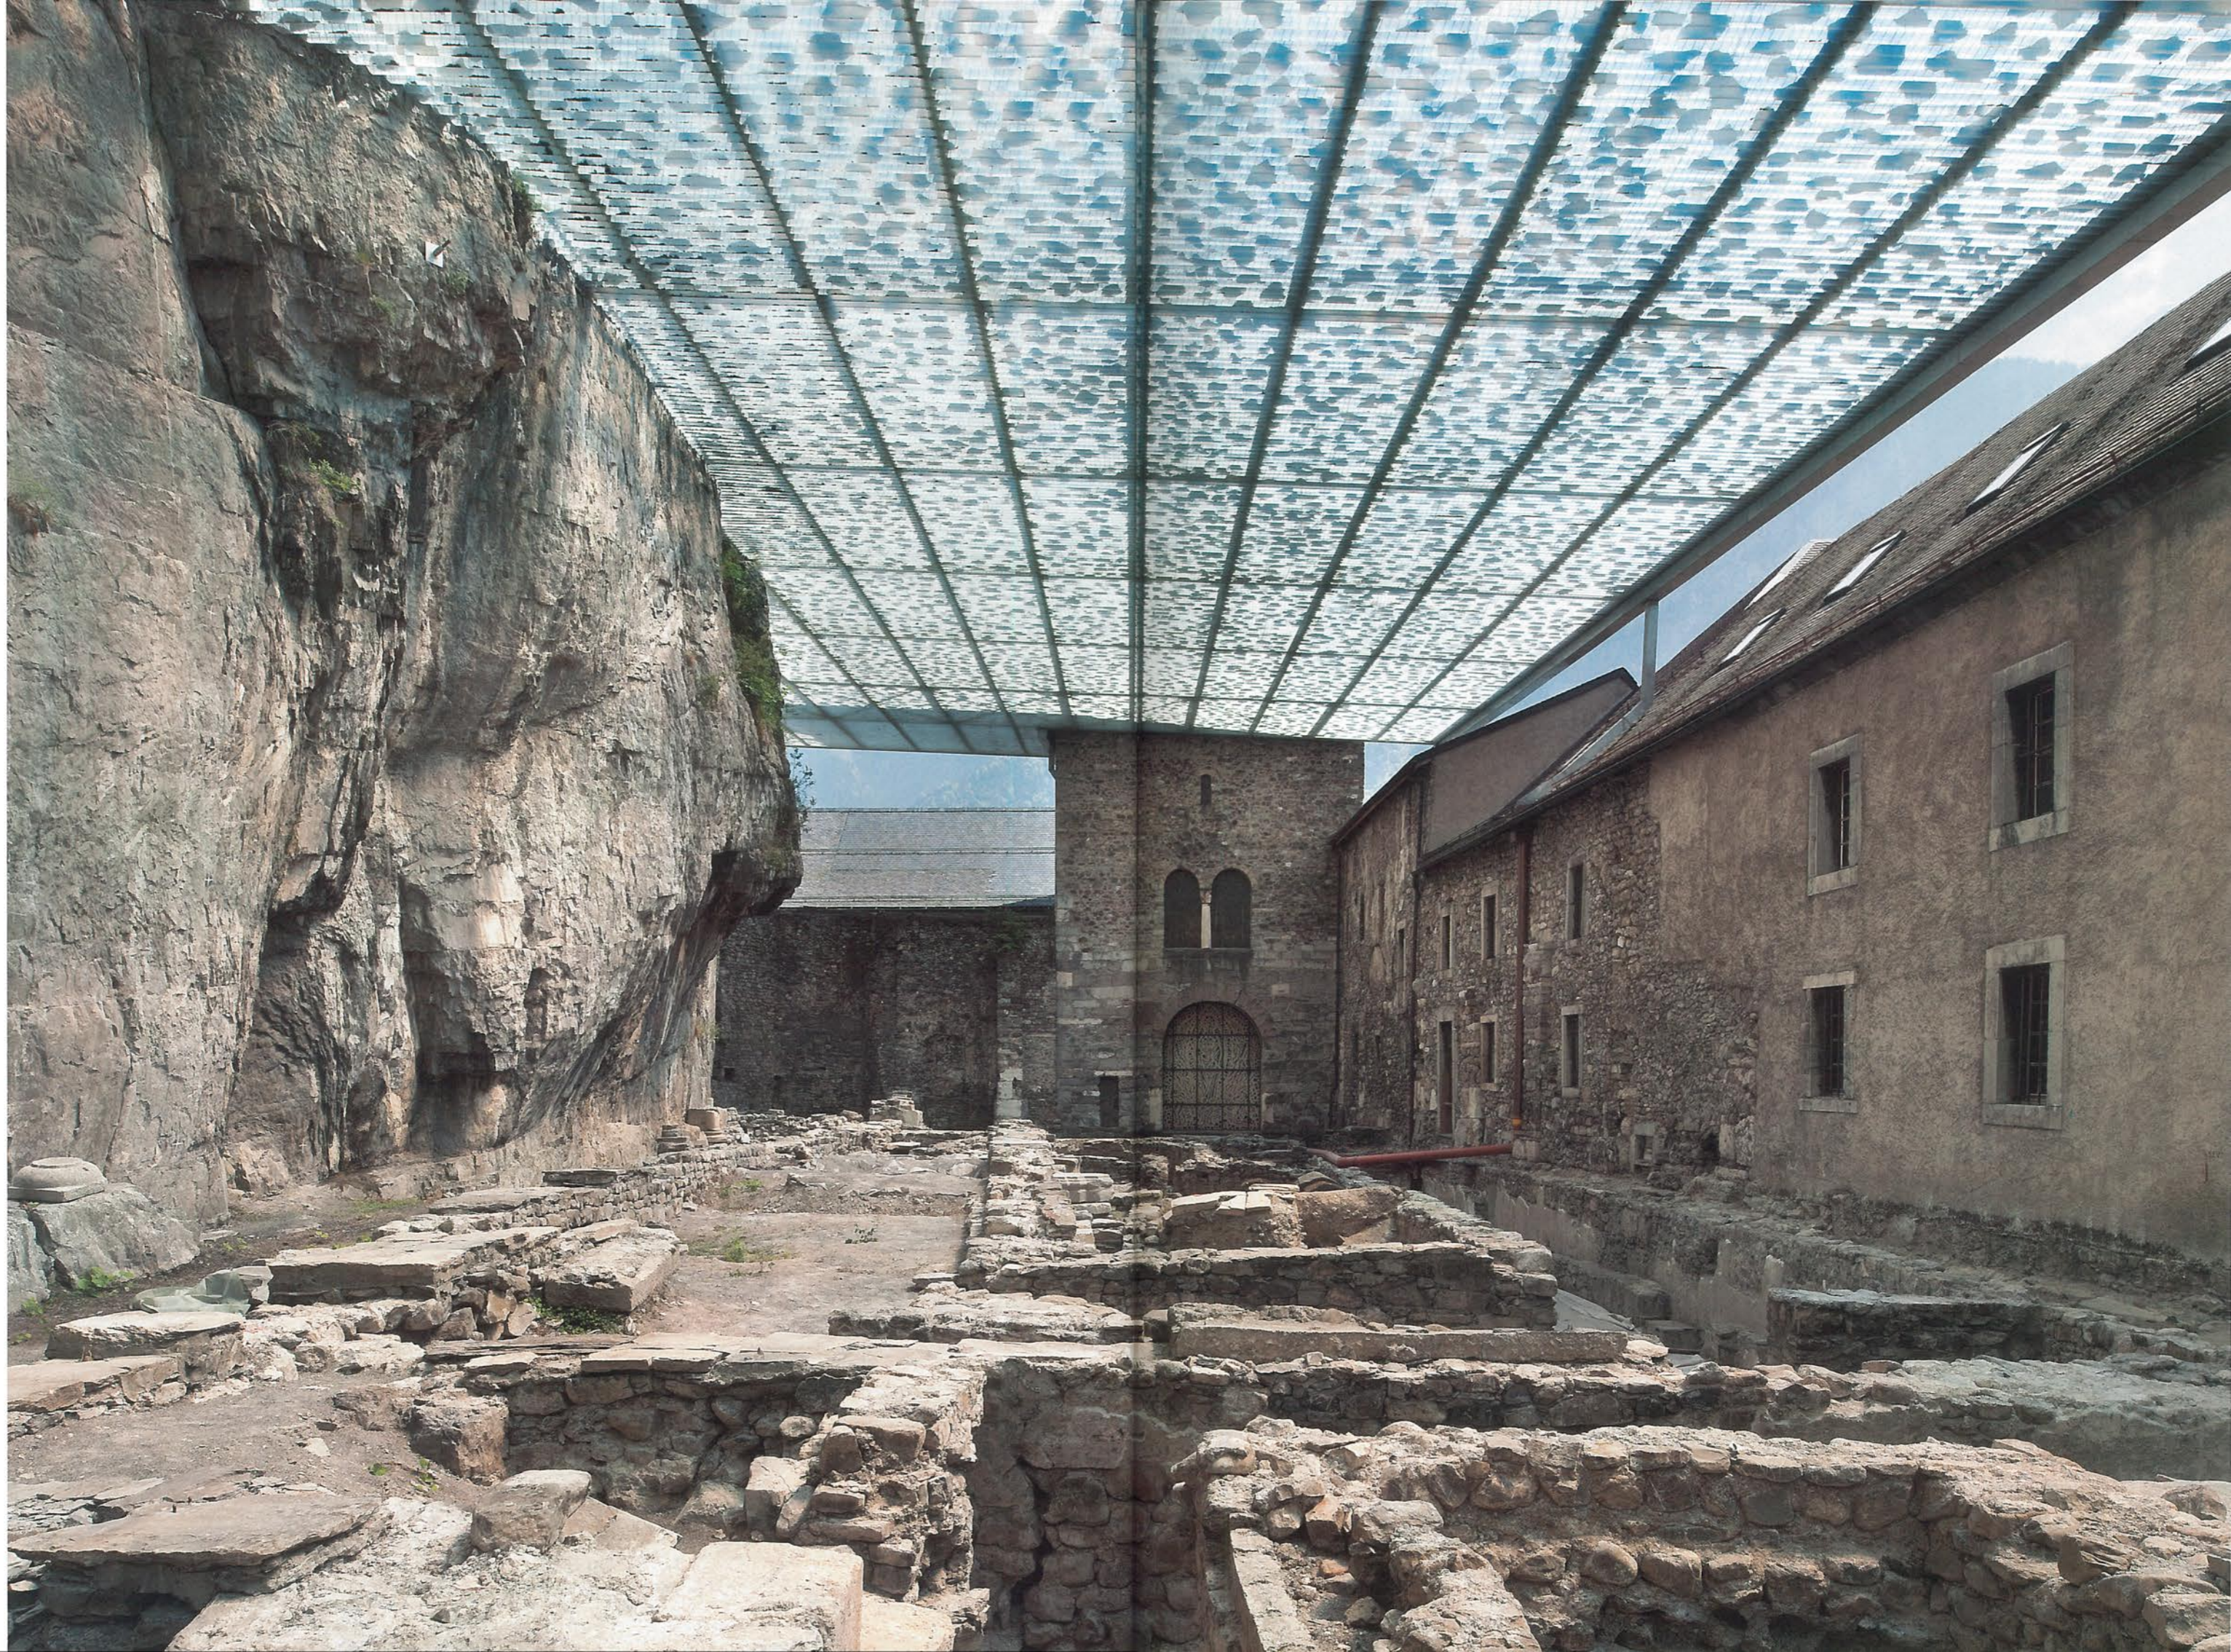
Our project endeavors to demonstrate this particular treat of history. By suspending 170 tons of stones, it expresses the ever lasting hazard the site had been exposed to. The roof gives the interior a calm and almost contemplative ambience. It is built above the fundamental buildings in order to keep the dialogue between the facades and the cliff face. The "stone-roof" serves as a filter for light and produces an evenly spread and regular illumination.

이 프로젝트는 이러한 생 모리스 수도원의 고된 역사를 되돌아보고, 이 땅에 새 생명을 불어넣기 위해 진행된 작업이다. 폐허처럼 남겨져 있던 기존의 건물 위로 지붕이 덮였고, 170톤에 달하는 돌이 다시 그 지붕 위에 놓였다. 한때는 수도원을 파괴하던 돌들이 이제는 수도원을 지키는 지붕으로 탈바꿈한 셈이다. 동시에 이 돌 지붕은 절벽과 기존 건물의 입면 사이에 특별한 관계를 맺어 주면서 고요한 명상의 공간을, 더불어 은은한 빛으로 가득한 신성한 공간을 만들어낸다.

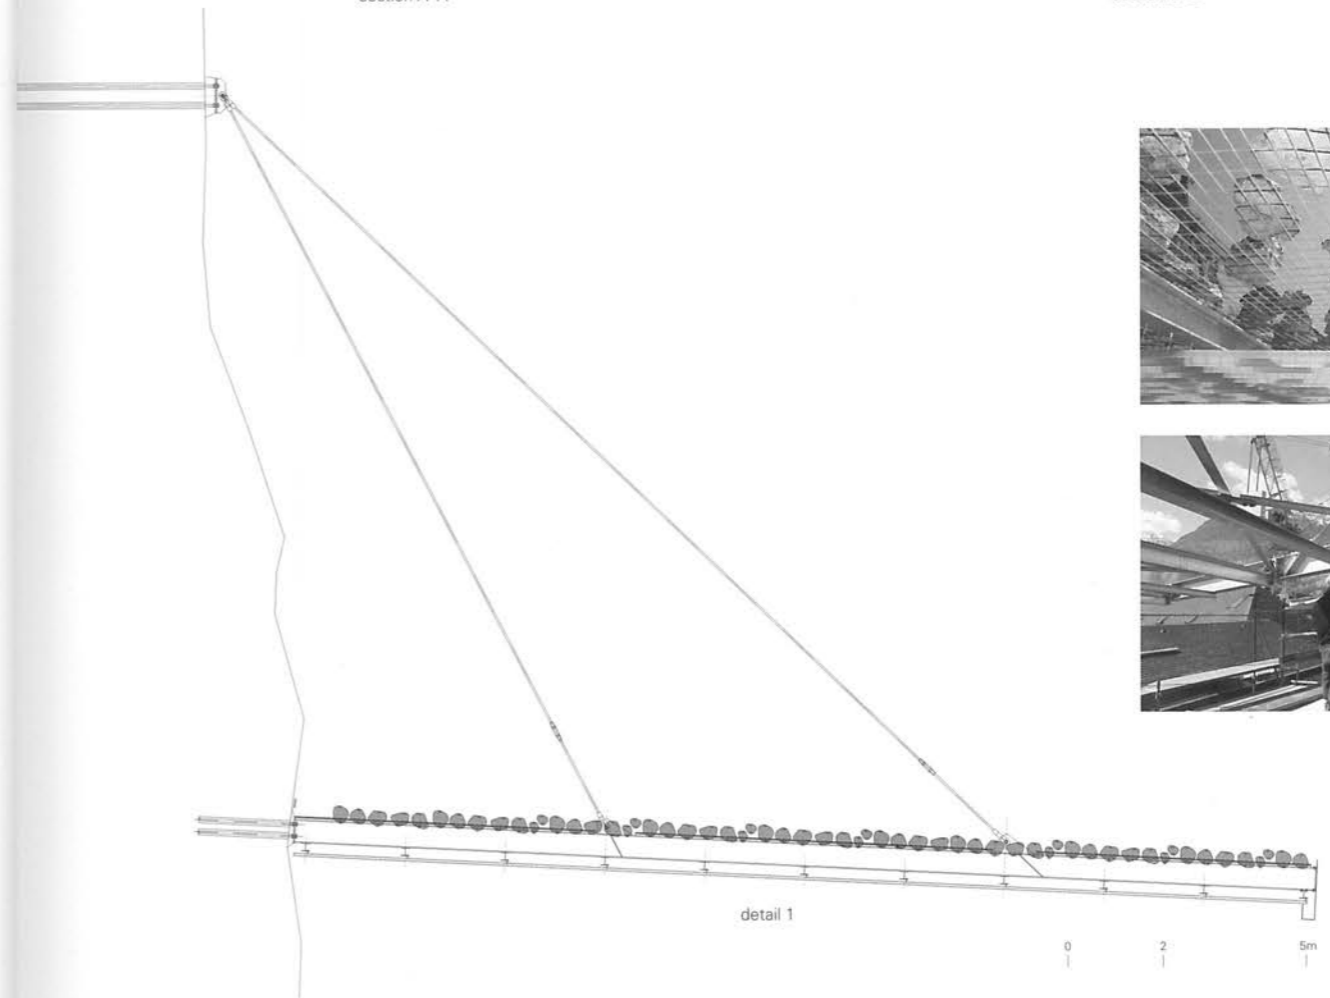
detail 1

stones 160kg/m²
 galvanized steel wire net 100/70mm
 KSA 55 steel beam
 IPE 500/le E355 I-beam
 HEA 160/le E355 I-beam
 waving neomat polyclair 177/51 cover

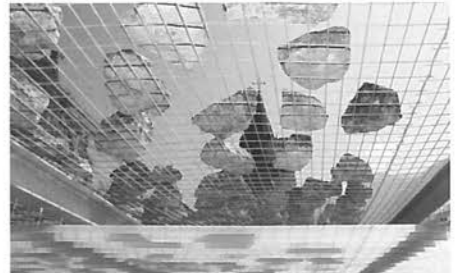
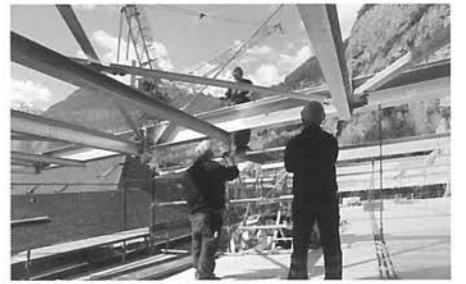
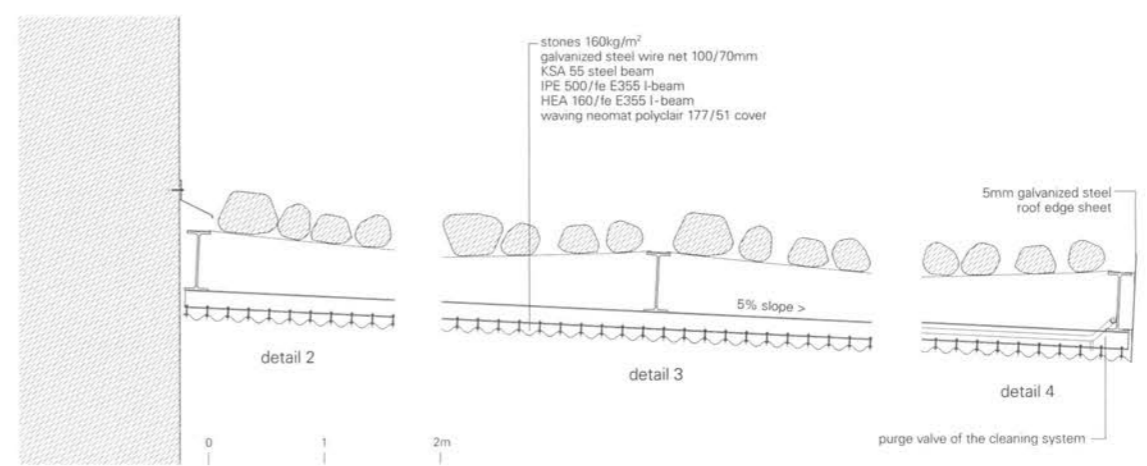
detail 2

detail 3

detail 4

5mm galvanized steel
 roof edge sheet

purge valve of the cleaning system
